Site of Former Dry Cleaners with Pneumatic Enhancement of Bedrock for Successful Cascade Chemistries Amendment Injection

PROJECT: Former Dry Cleaners with Contaminated Bedrock

LOCATION: New Jersey

SERVICE: In Situ Injection, Colloidal iZVIT™, Fracturing

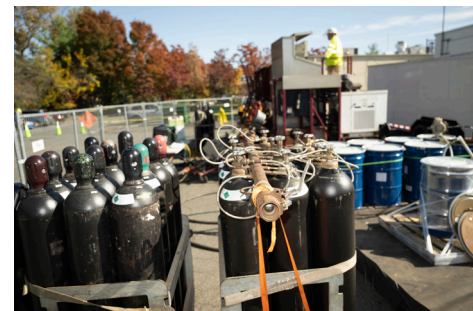
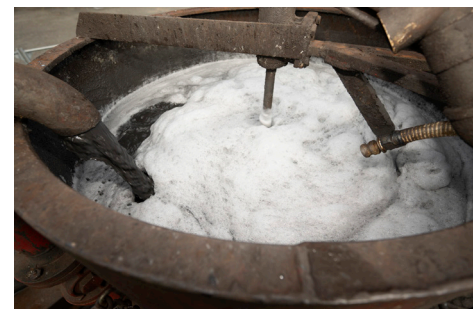
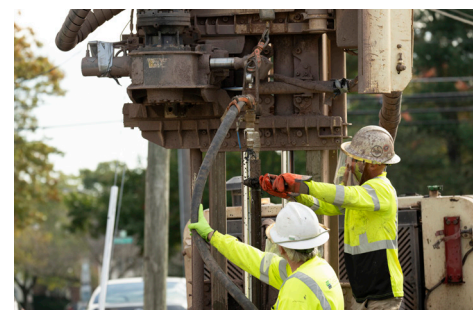
Pneumatic enhancement was performed to enhance the radius of influence by increasing the bulk permeability of the target zone. The target treatment zone (TTZ) was both near and under buildings in active use, including a donut shop. These buildings were within 15 feet of the client's designated pneumatic enhancement points, creating the potential for structural impacts. A structural analysis was required to perform pneumatic enhancement within 15 ft of the on site structures.

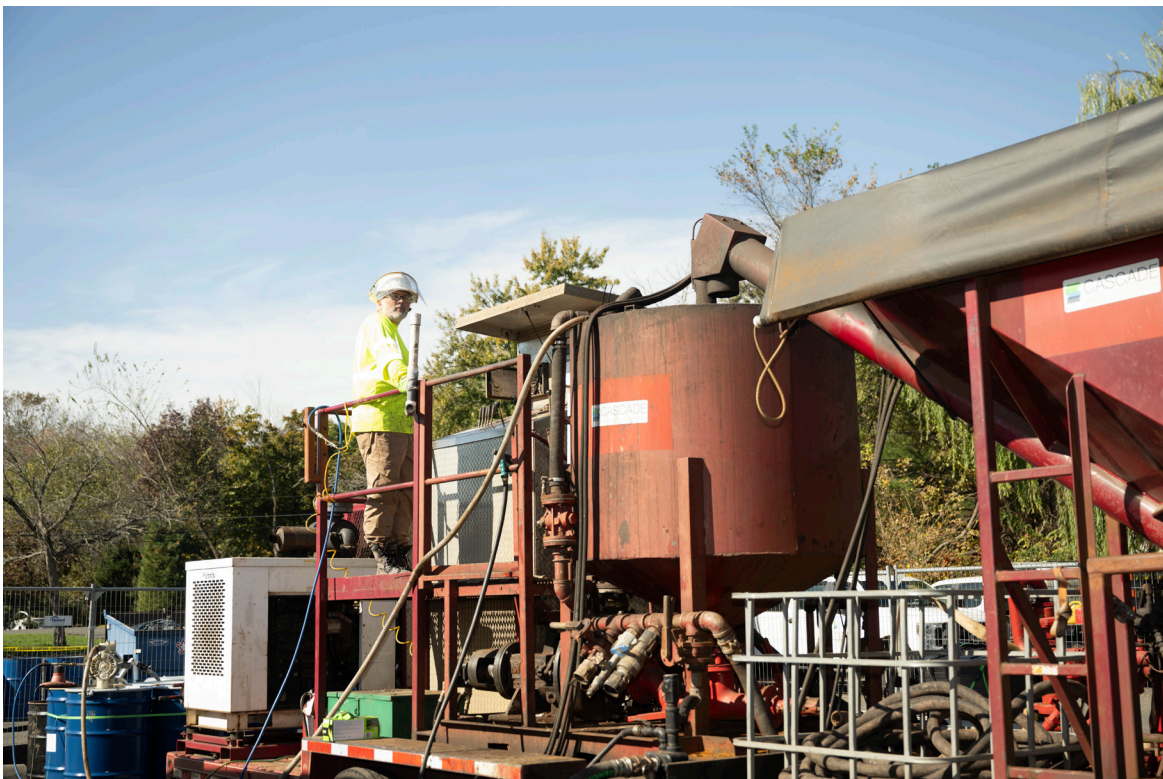
Cascade proposed to drill several injection points, and to complete pneumatic enhancement at each point through discrete three-foot vertical treatment intervals with the application of nitrogen gas for several seconds that would increase the bulk permeability of the formation and increase the radius of influence of amendment injection.

After the Cascade team completed the pneumatic enhancement event, they would then mix and inject the amendment. The proposal was to inject Colloidal iZVI™ from Cascade Chemistries, a colloidal (5 um) injectable zero valent iron. VCs/DCEs are traditionally more difficult to treat with smaller surface areas of micro-scale ZVI (~90 micron). Colloidal iZVI's particle size would achieve a larger target radius of influence (ROI) of 20 feet with less pressure, which is key when working near sensitive structures and under buildings. Colloidal iZVI is more reactive than ZVI and would reduce the VCs/DCEs. Colloidal iZVI offers high persistence and a pre-blended suspension crafted to eliminate field issues such as ignition or clumping. Through processes known as reductive dichlorination, contaminants are degraded upon contact with Colloidal iZVI.

During each injection event, system operational parameters including down-hole initiation and maintenance pressures at the injection point, pressure influence at surrounding monitoring points, and ground surface deflection at the injection point and at building load points were observed and collected.

There is a direct correlation between total dissolved iron concentrations in wells and CVOC reduction. The total dissolved iron represents the distribution achieved during injection and varies depending on the fractures available during pneumatic enhancement and subsequent Colloidal iZVI injected. For one monitoring well, VC was reduced from 46 ug/l to 0.85 ug/l and total dissolved iron concentration was increased from 280 ug/l to 124,000 ug/l. For another well, Cis 1,2 DCE was reduced from 1400 ug/l to 40 ug/l, VC was reduced from 780 ug/l to 25 ug/l and dissolved iron increased from 19.5 ug/l to 42,100 ug/l. For the other wells, Cis 1,2 DCE and VC changes also correlated to the dissolved iron noted in these wells post-injection. The wells will continue to be monitored for up to a year and further reduction in contaminants is expected.
